RE: Monthly Progress Report No. 86

Ciba Specialty Chemicals, 180 Mill Street, Cranston, RI 02905

EPA ID RID001194323

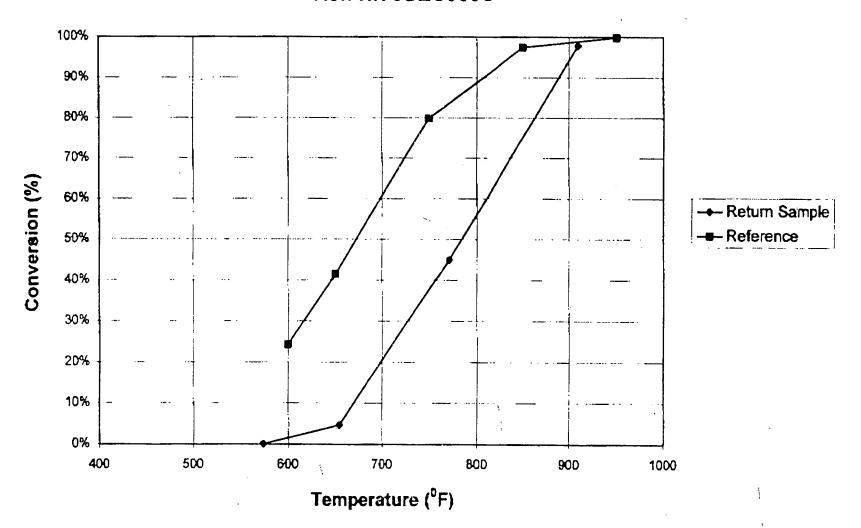
Trichloroethylene Activity Return Sample Ciba Geigy Ref.-Nr. 3SEC060C

The poison scan did not reveal any significant levels of catalyst poisons. The BET surface area analysis shows a 26.8 % reduction in surface area.

It is suspected that the reduction in catalytic activity is caused by masking of the active catalyst sites by organic solids. It may be possible to restore the catalyst activity through thermal regeneration or washing of the catalyst.
